Inspection Report

Property Address:
123 Anywhere
Montgomery AL 36117

Central Alabama Property Inspections

Date: 8/3/2011	Time: 10:00 AM	Report ID: 1690
Property: 123 Anywhere Montgomery AL 36117	Customer: Jane Doe	Real Estate Professional:

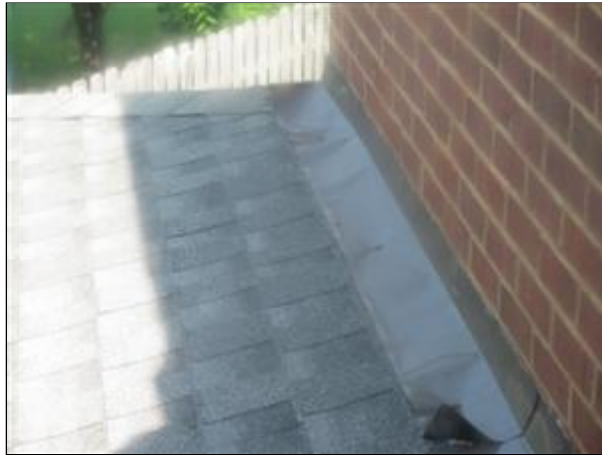
1.1 Picture 1

1.1 Roof flashing at back right end along brick wall and shingles shows 2 raised/loose areas. See section 1.1 photo 1.

Roof flashing at back right end along brick wall and shingles shows 2 raised/loose areas. See section 1.1 photo 1.

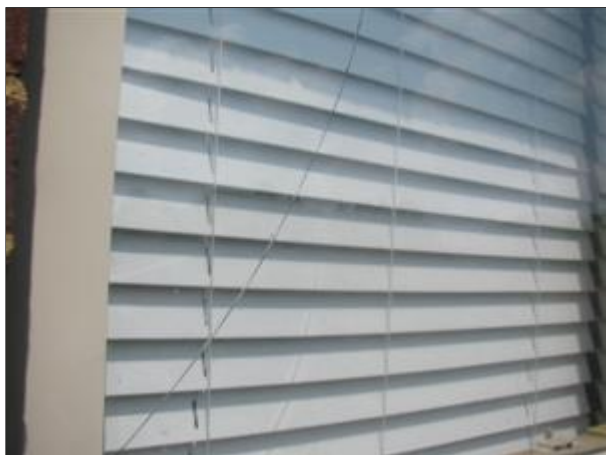
2.2 Picture 1

2.2 (1) Garage center double pane window shows 1 of 2 panes cracked. (2) Upstairs center bedroom window and master bedroom left window show some moisture between glass panes from seal leakage due to sun/heat exposure. See section 2.2 photos 1, 2 & 3.

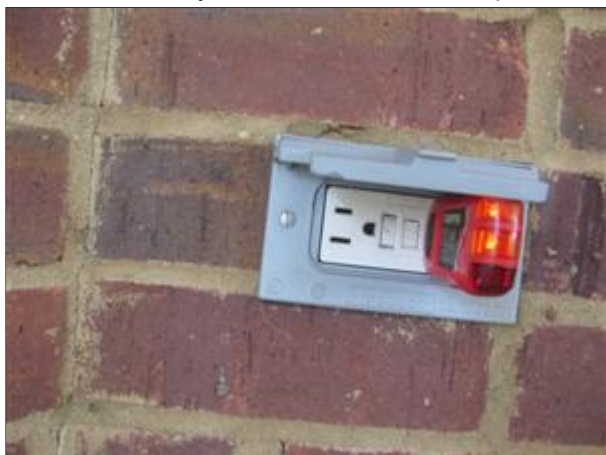
7.5 Picture 1

- 7.5 (1) Exterior GFCI (ground fault circuit interrupter) outlet right of back door not tripping with outlet test button or test tool.
(2) Kitchen outlet at end of cabinet right of sink not ground fault protected by any of the kitchen GFCI's present. Outlet within 6 feet of sink. Safety issues, see section 7.5 photos 1 & 2.

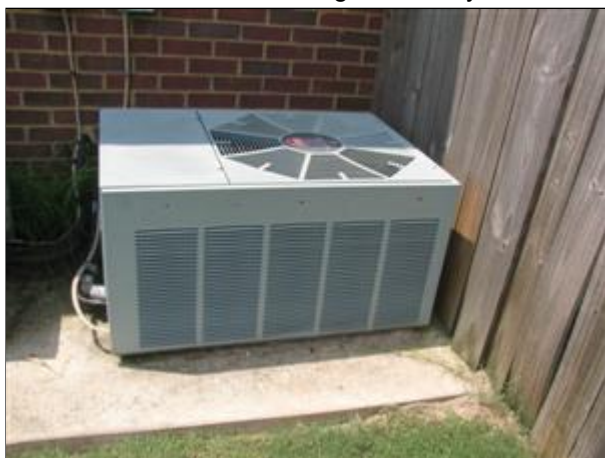
8.8 Picture 1

8.8 Upstairs air conditioner not cooling to industry standards. See section 8.8 photo 1.

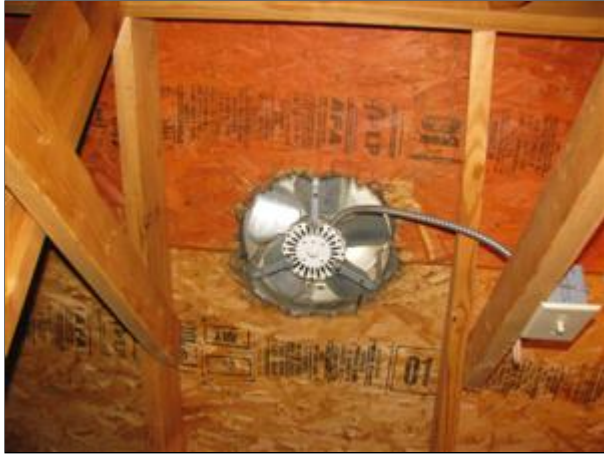
9.3 Picture 1

9.3 Both attic thermostat controlled ventilation fans not working. See section 9.3 photos 1 & 2.
